POST CONSTRUCTION INSPECTION REPORT OF RADAR TOWERS

SITE: LANDRIENNE RADAR

ENVIRONMENT CANADA

MCA REFERENCE N°: 1642-100-1

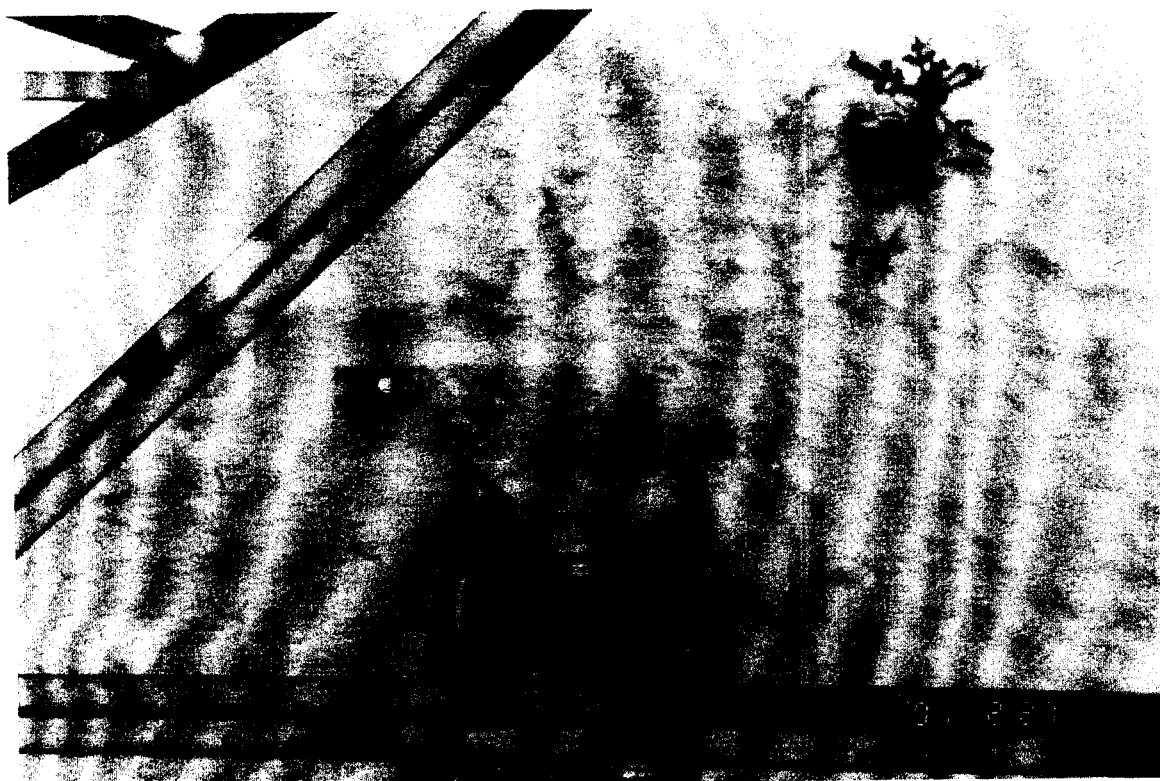
photo # 3

- 5.4 The base of the stair stringers does not rest on its foundation (i.e. a concrete step) (Photo no. 3). We recommend casting another foundation to adequately support the stair stringers to take into account the existing field condition.

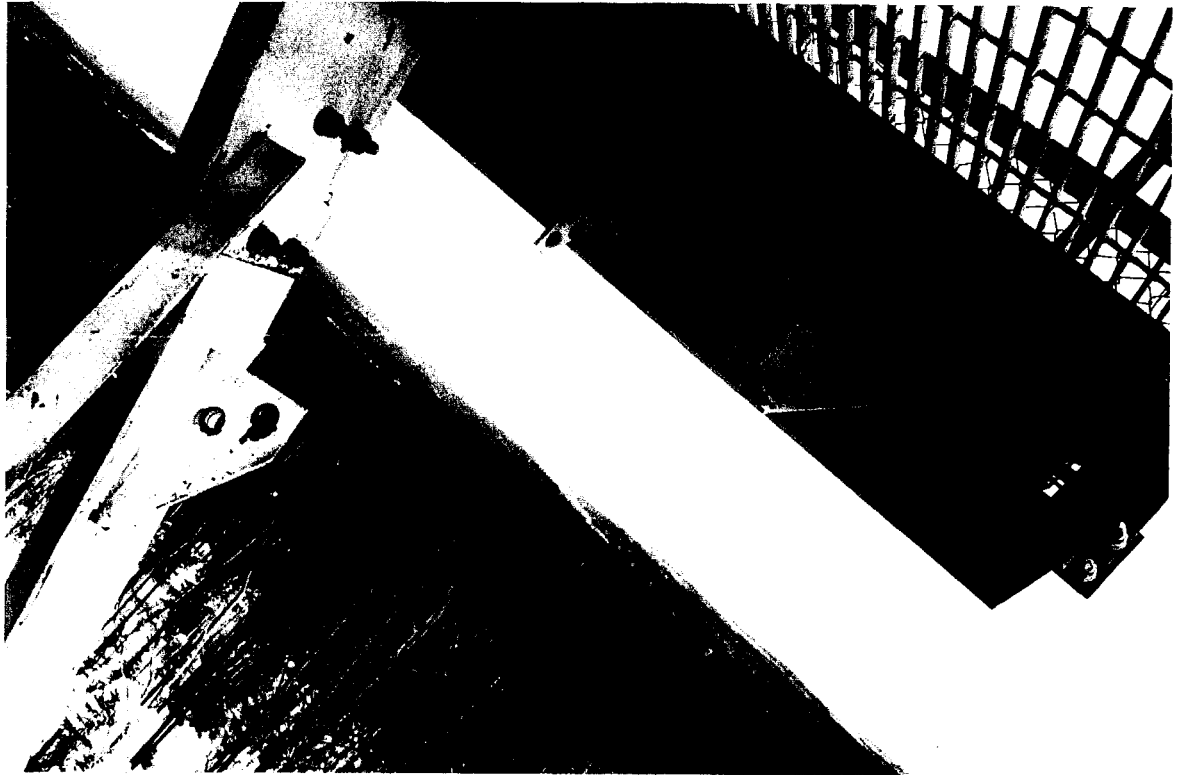
photo # 5

- 7.3 Three diagonal members are missing under the catwalk at elevation 21 m (Photo no. 5). We recommend installing these members.
- 7.4 There are two damaged secondary horizontal members on the tower (Photo no. 6). We recommend replacing them.

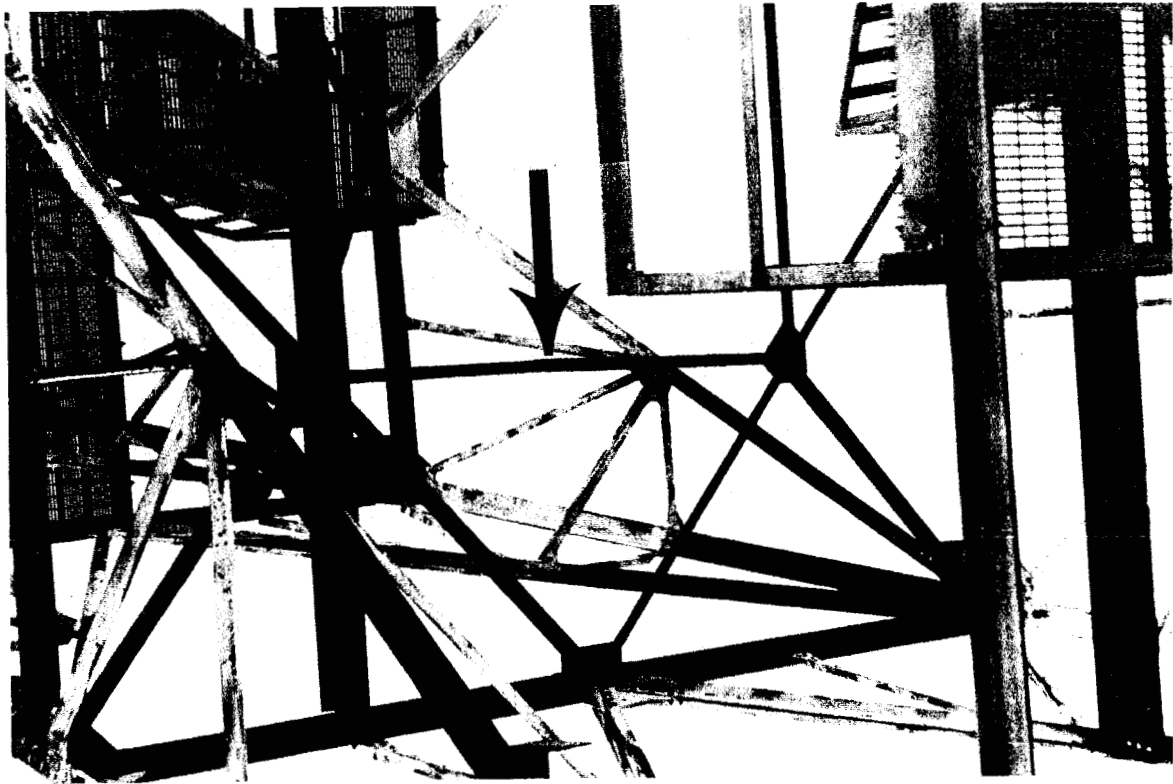
photo # 8

- 7.6 The interior bracing member parallel to face 4 at elevation 12.6 m is bent (Photo no. 8). We recommend replacing this member.
- 7.7 There are numerous openings in the steel wire woven mesh at the platform levels (Photo no. 9). We recommend rectifying the situation.

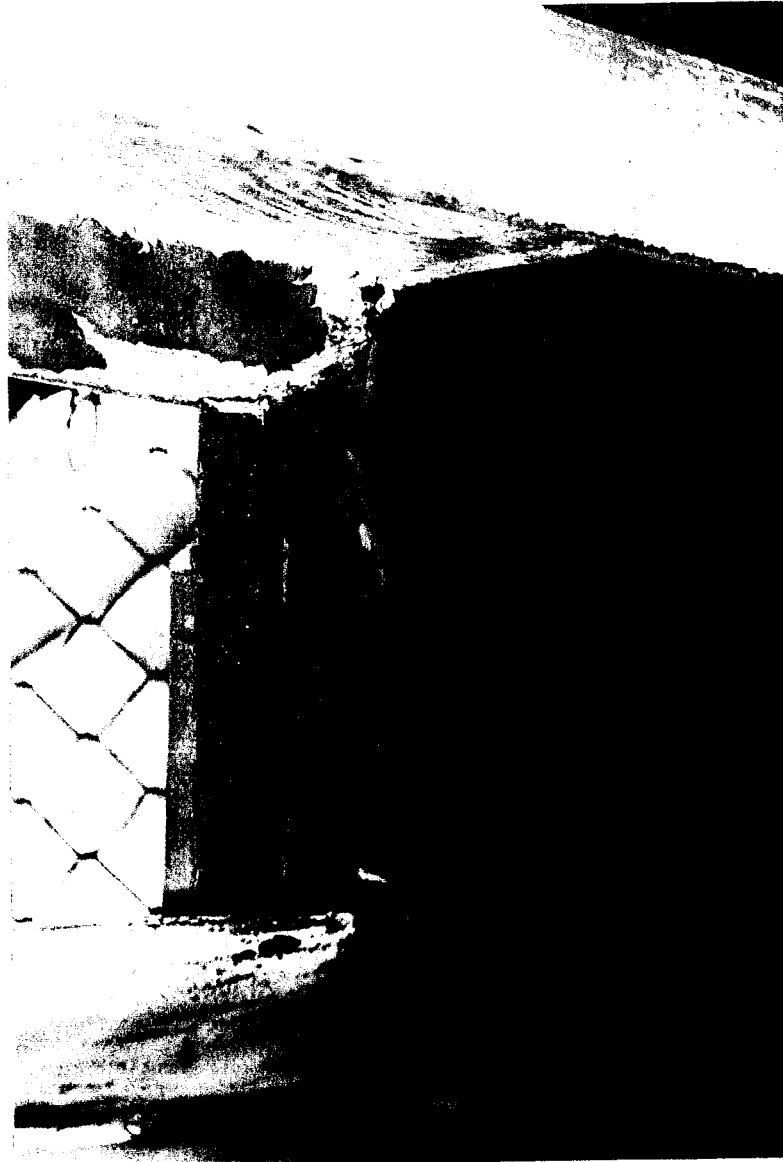
photo # 10

- 7.8 There is a slight step in the grating platform at elevation 10.5 m (Photo no. 10). The step is due to the fact that one of the stringers is slightly lower than the other one. We recommend adding shims on the entire length of the stringer supporting the grating.

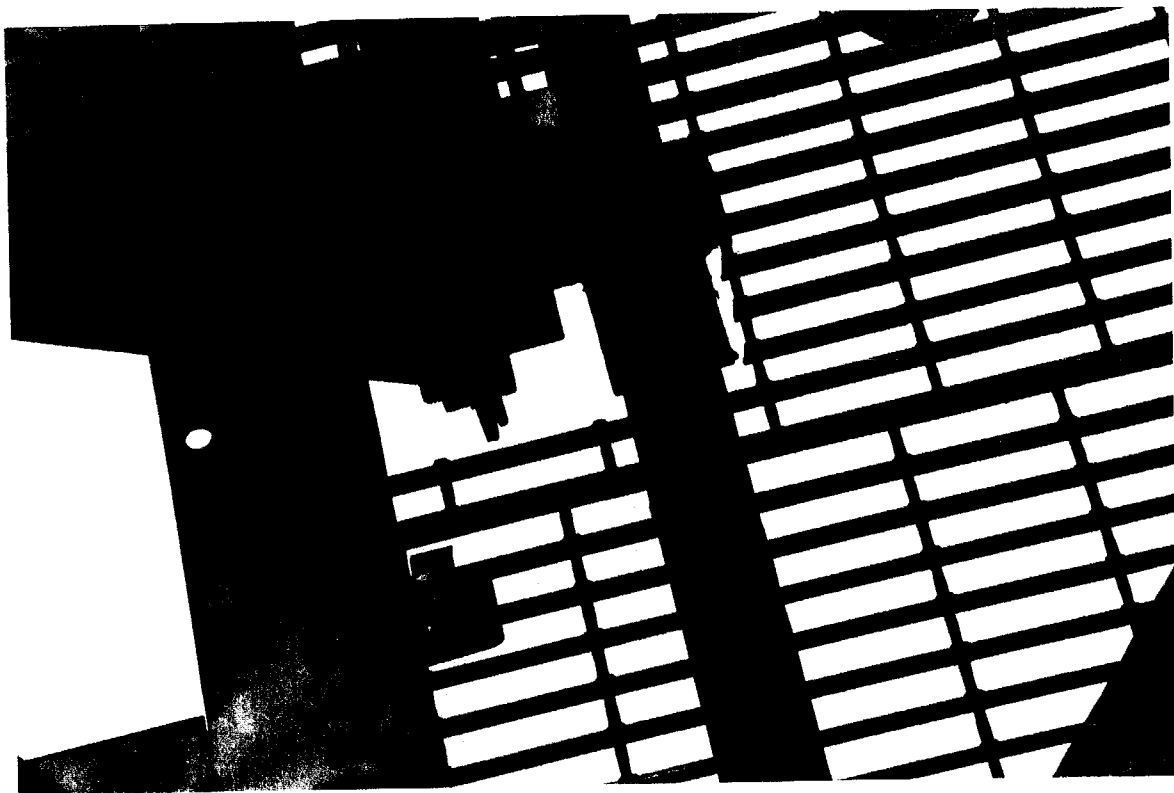
photo # 11

- 8.5 The stair section between elevation 6 m and 10.5 m is not attached at elevation 6 m (Photo no. 11). We recommend rectifying the situation.
- 9.1 Due to field conditions, a few welds were done in the field. We believe that the galvanizing was not removed before proceeding with the welds. As a result, the weld metal was mixed with zinc producing poor weld quality. Also, these welds are not seal welds and are starting to rust (Photo no. 12, 21 and 22). The Contractor's Engineer is to certify that these welds are sufficient for the present loads, and if not, the Contractor must rectify the situation.

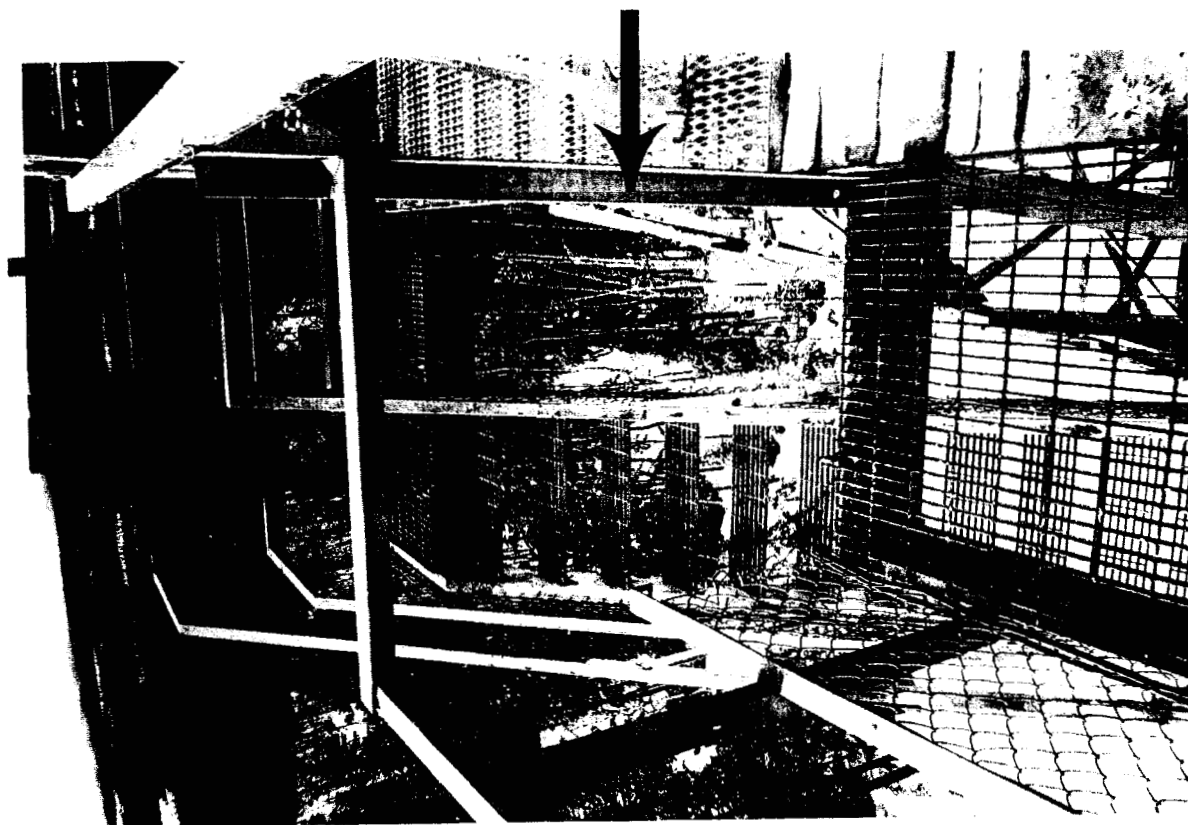
photo # 13

- 7.10 On the last catwalk level, a section of the handrail is too low and one mid-span member is missing (Photo no. 13). We recommend rectifying the situation.

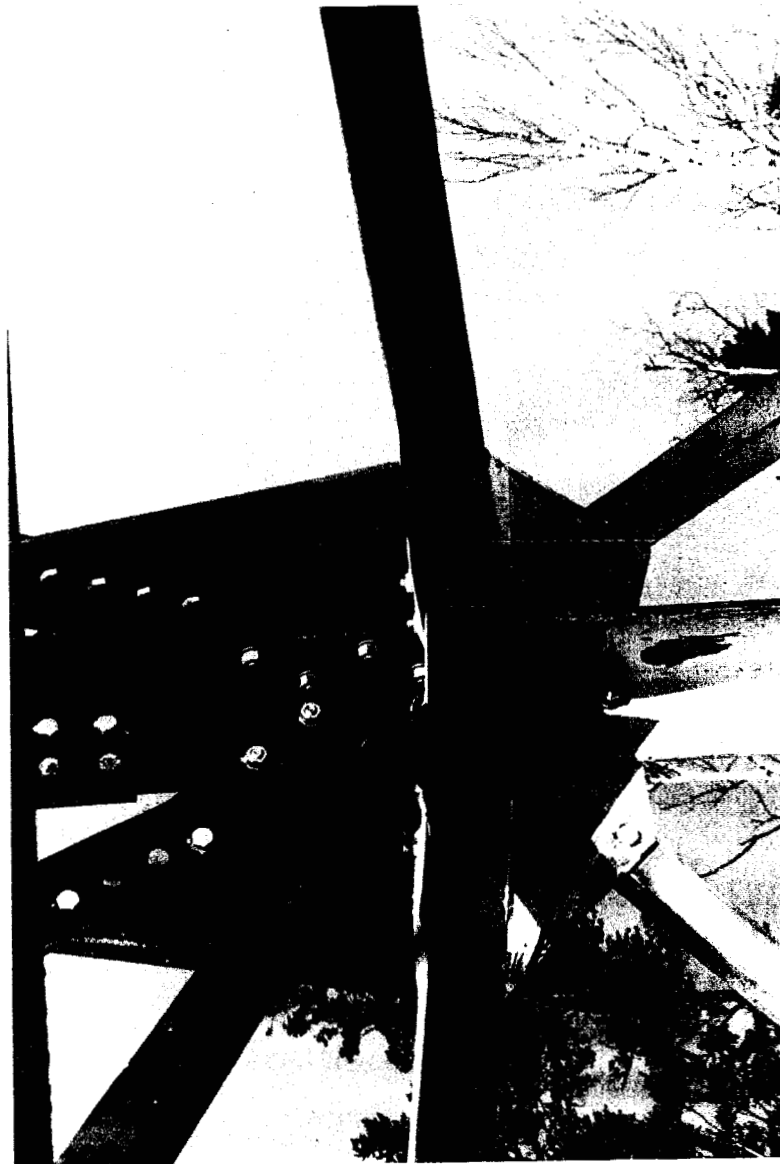
photo # 14

- 8.1 Approximately 30 % of the 5/8" dia. A325 bolts sampled were not tightened adequately. To verify if bolts are properly tightened, we use a conservatively low inspection torque value for galvanized 5/8" dia. A325 bolts of 130 lbs-ft. Also some of the bolts are visually loose (Photo no. 14, 15 and 16). We recommend verifying that all of the bolts are tightened properly.

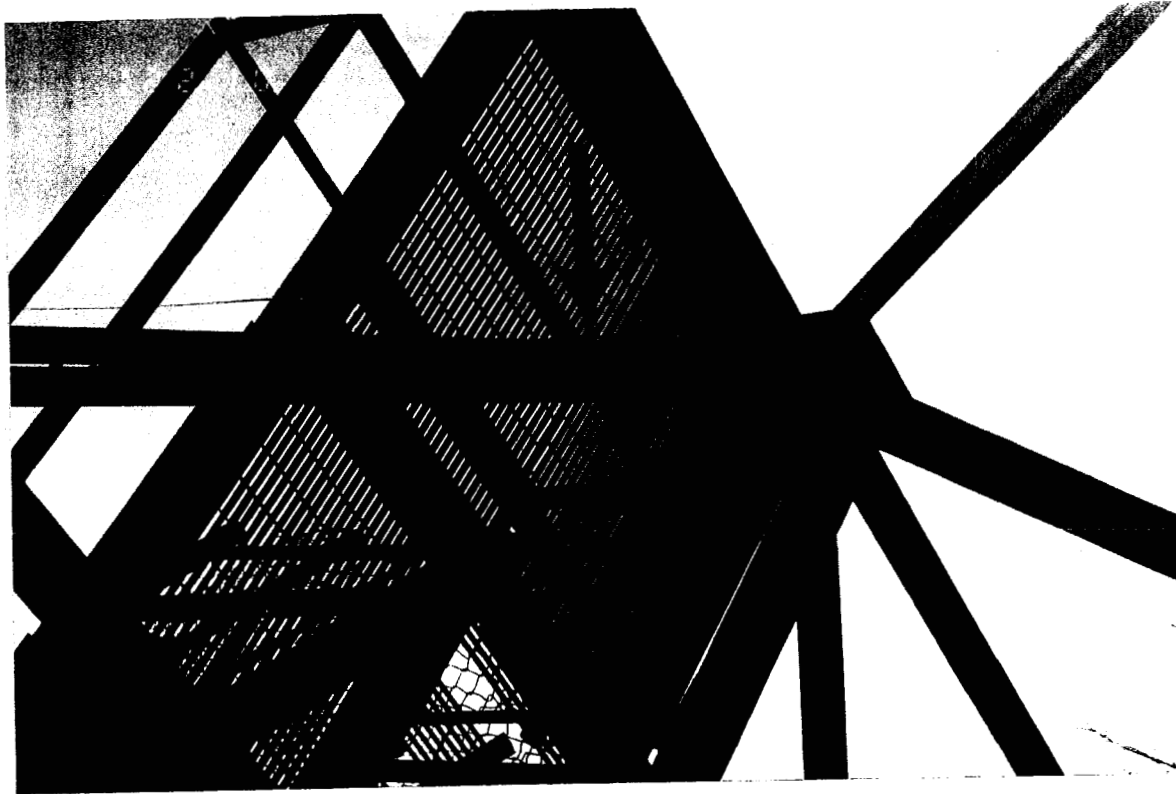
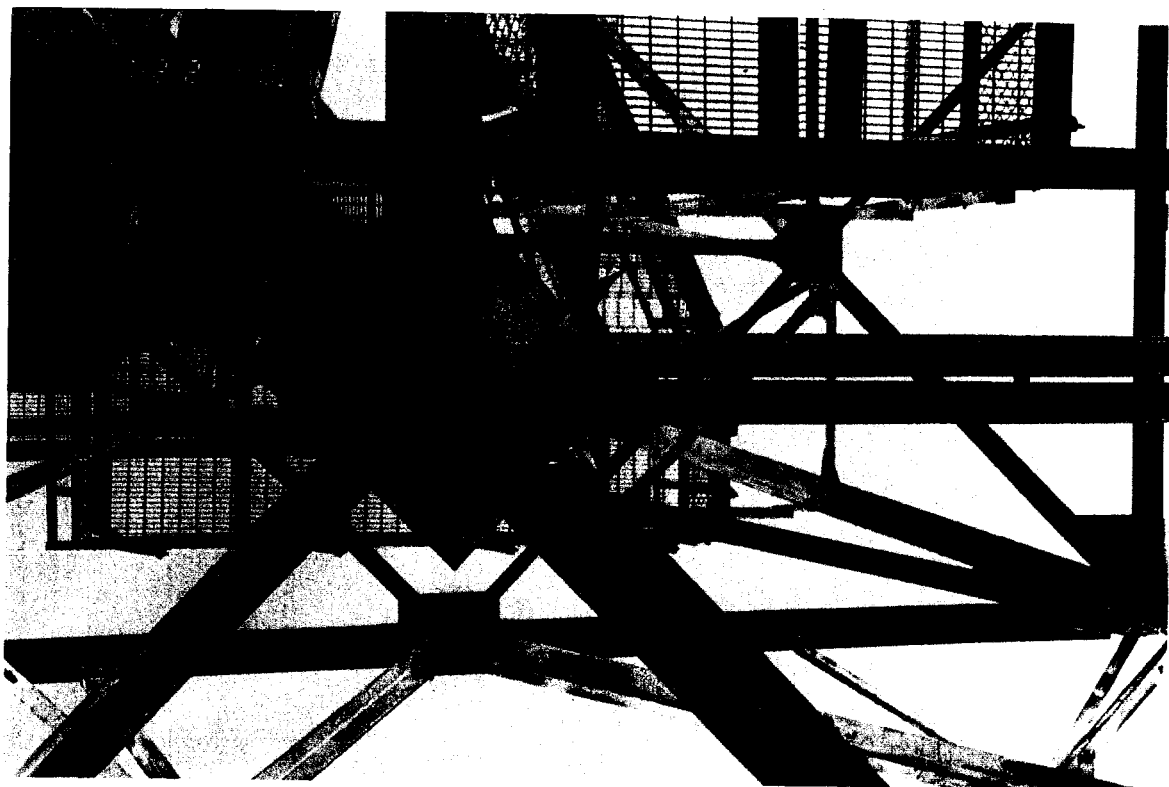
- 8.3 Some spacers are missing at stitch bolts locations at elevation 6 m ± (Photo no. 18 and 19). We recommend rectifying the situation.
- 8.4 The stair section between the ground and elevation 6 m is not properly attached to the platform, two bolts are missing (Photo no. 20). We recommend rectifying the situation.

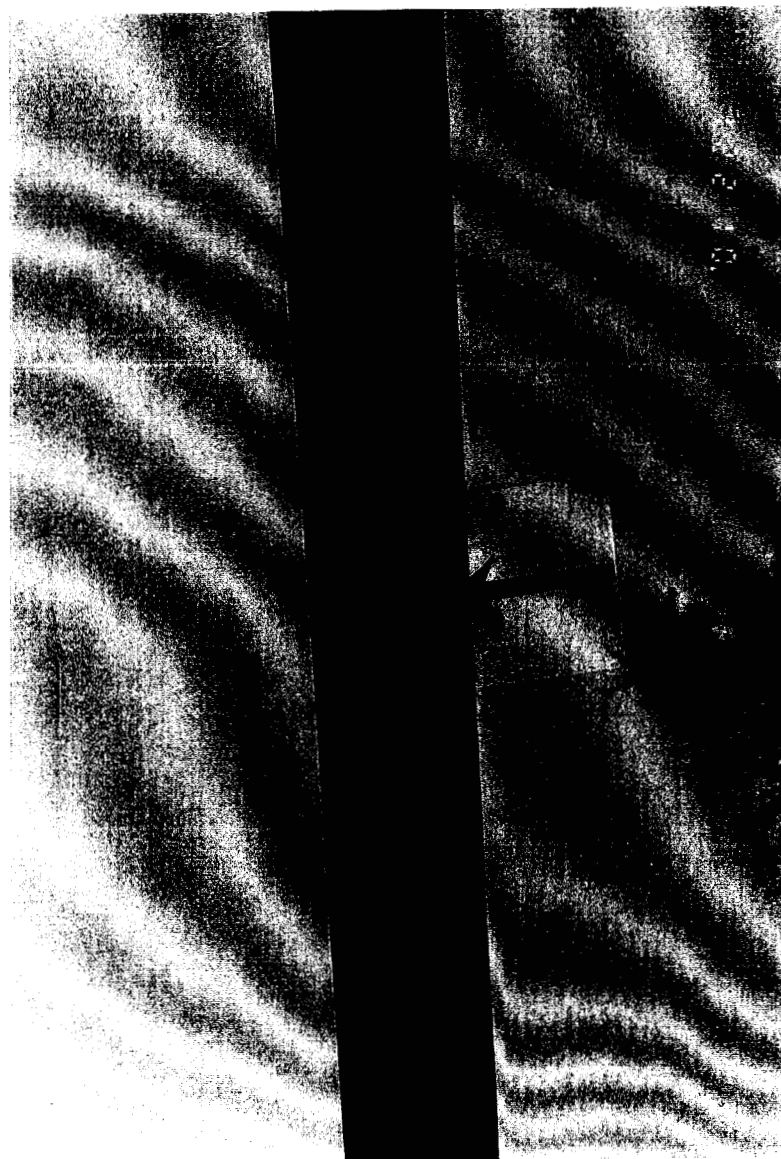
photo # 17

- 8.2 Many bolts are missing on the back to back horizontal members and on the interior bracing back to back members at elevation 6 m ± (Photo no. 17). We recommend rectifying the situation.
