## **DESIGNATED SUBSTANCES SURVEY**

**The Centre Block Building  
111 Wellington Street, Parliament Hill  
Ottawa, Ontario**

**PWGSC SOA No: EN438-090265/001/FK**

**January 21, 2013**

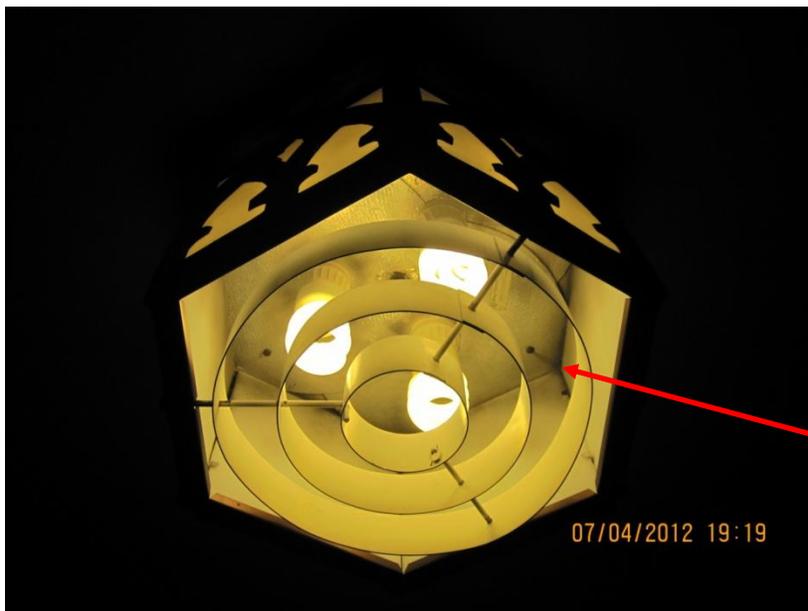
- Heritage plaster elements are assumed to contain asbestos and were not sampled in order to avoid damage;
- Light heat shields. Samples were not collected in order to avoid damaging historical / heritage light fixtures;

**Photo 1:** Light heat shields are suspected to contain asbestos. The material was observed in good condition in light fixtures throughout the building.

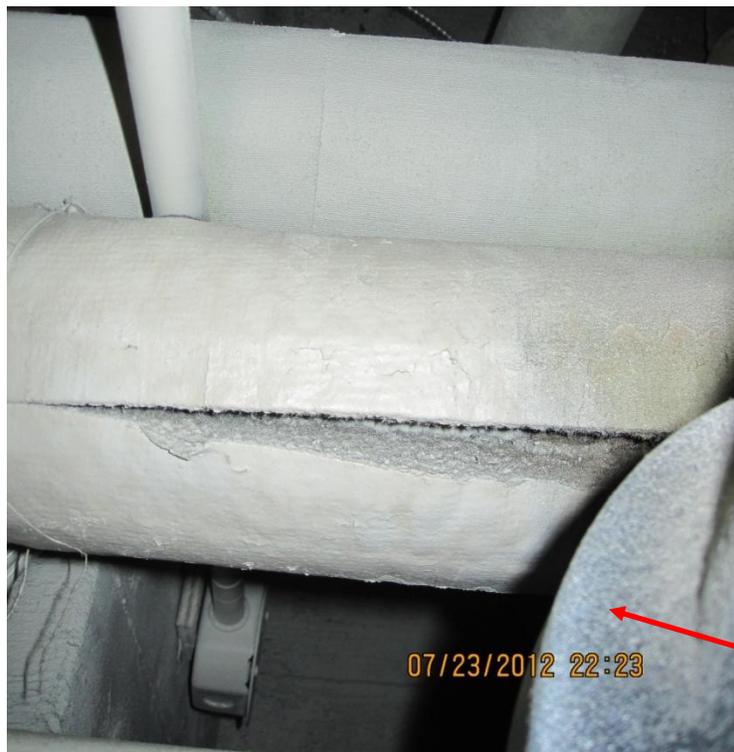
**Photo 2:** Asbestos-containing aircell (previously sampled) was observed in various locations throughout the building, predominately in the basement.

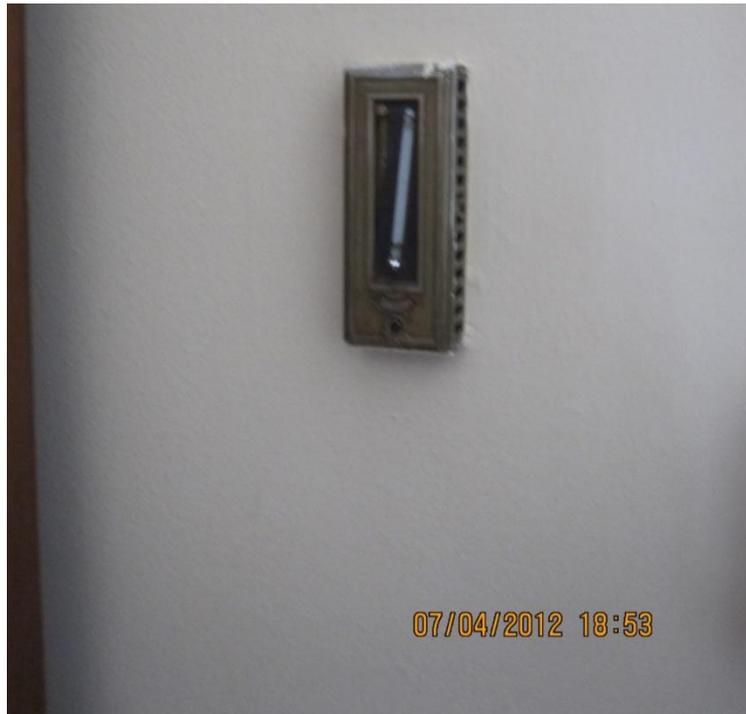
**Photo 3:** Mercury containing thermostats were observed in select rooms of the building. They were reportedly not in use and were left place following a retrofit of the building.

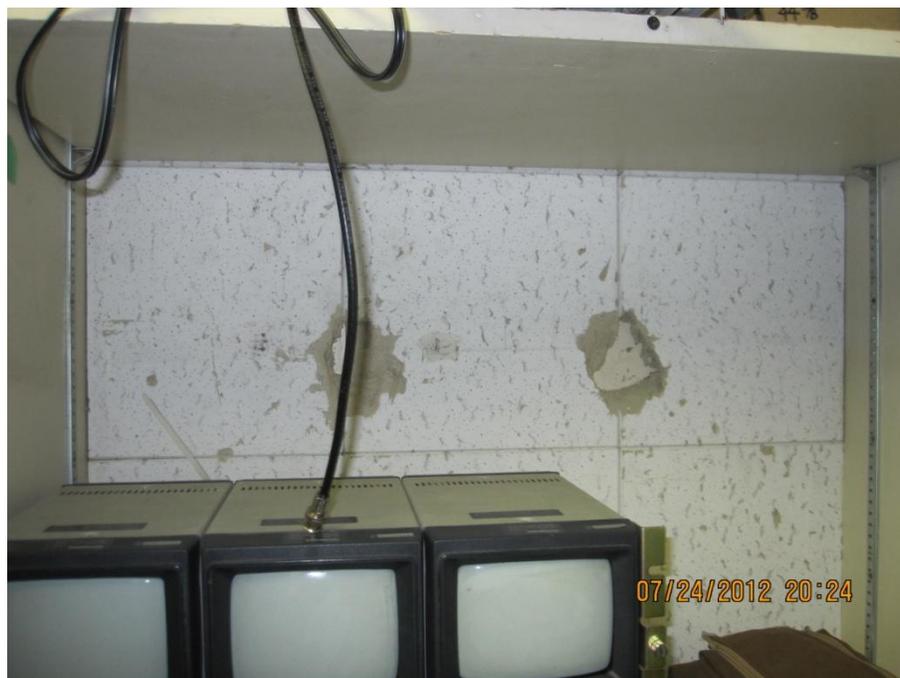
- 1' x 1' Acoustic Wall Tiles, (previously sampled, 1998) observed in select areas on the first and third floor contains 0.5-5% Amosite and 5-25% Chrysotile;
- 2' x 4' Ceiling Tiles, Pinhole (previously sampled, 1998) observed in select offices on various floors contains 0.5-5% Amosite and 5-25% Chrysotile;
- 2' x 4' Ceiling Tiles, Pinhole (Sample 14755-14A and 14755-42A) observed in select offices on various floors contains 1% Chrysotile; and
- 2' x 2' Ceiling Tiles, pinhole, red back (Sample 14755-18A) observed in select rooms on various floors contains 0.8% Amosite.

**Photo 4:** 1' x 1' Acoustic Wall Tiles, (previously sampled, 1998) observed in select areas on the first and third floor contains 0.5-5% Amosite and 5-25% Chrysotile.

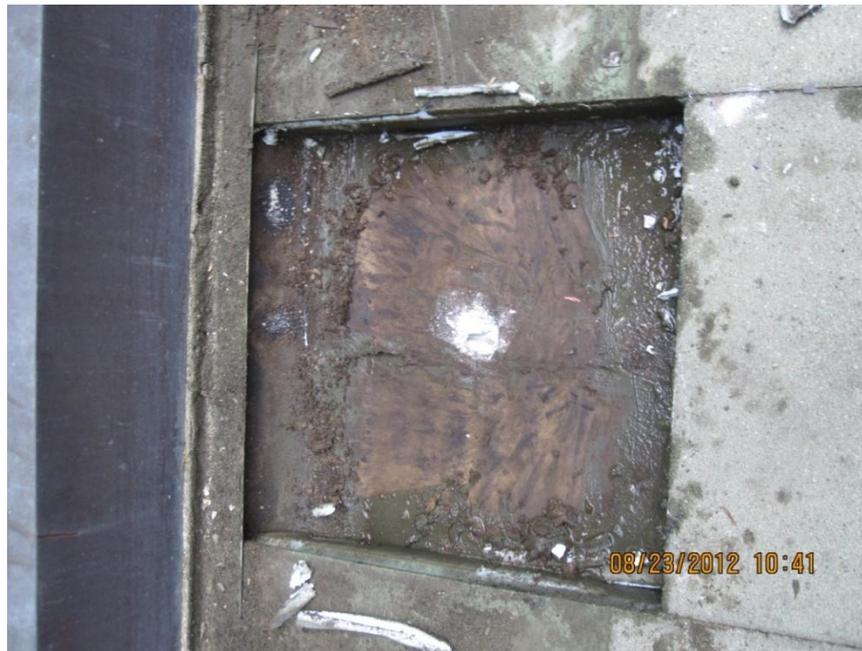
**Photo 5:** Roofing material, inverted roofing system (Sample 14755-65A-C and 66A-C) sampled from the sixth floor and second floor courtyard were sampled and do not contain regulated amounts of asbestos.

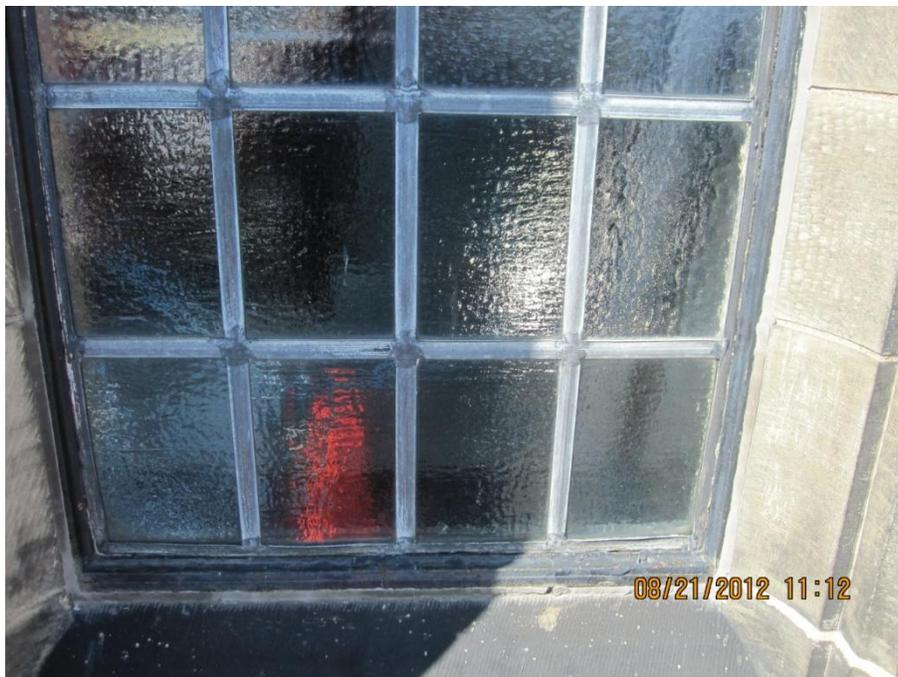
**Photo 6:** Exterior window, west face of building. Caulking from the outside of these windows was reportedly newer, and was sampled and found to not contain regulated amounts of asbestos.

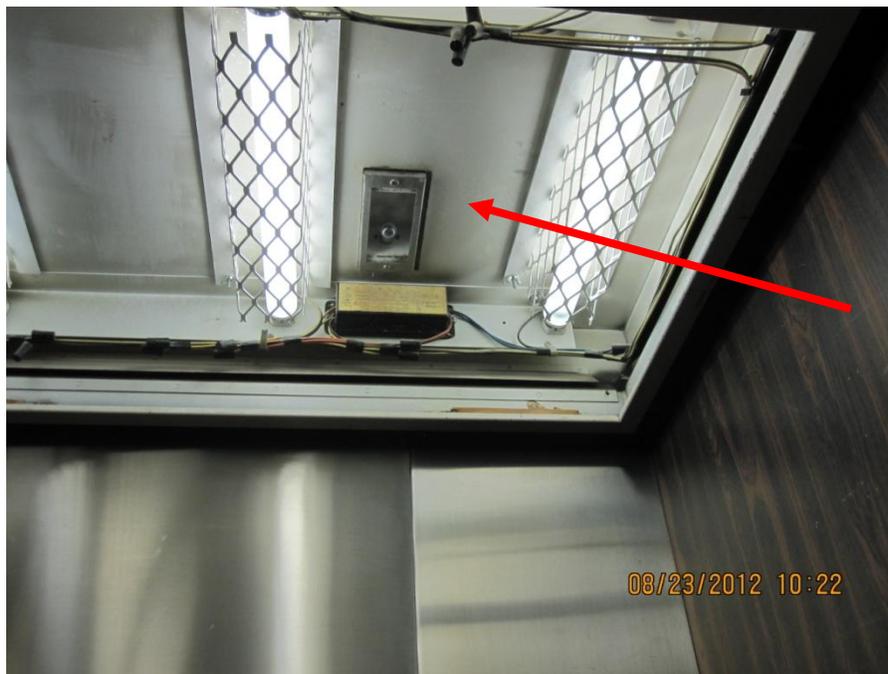
Polychlorinated Biphenyls (PCBs), also known as Chlorobiphenyls, are hazardous chemicals which were used in the manufacturing of a variety of equipment, such as electrical equipment, heat exchangers, hydraulic systems, and for several other specialized applications. PCBs are commonly found within electrical ballasts manufactured prior to 1981, found within fluorescent light fixtures and high intensity discharge (HID) lamps.

**Photo 7:** Suspected PCB-containing light ballast was observed in the elevator at the rear of the building. Fluorescent light ballasts associated with the T12 light fixtures in the building are suspected to contain PCBs.

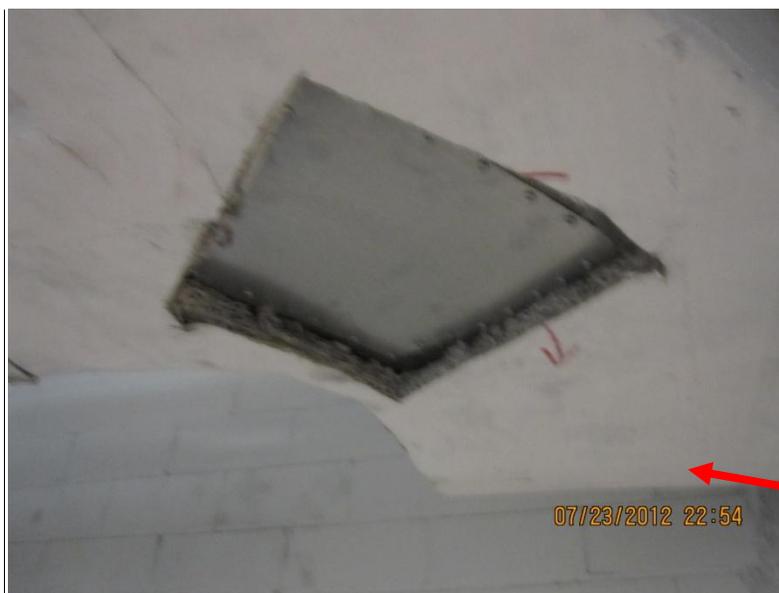
**Photo 8:** Aircell insulation on ductwork (previously sampled, 1998) contains regulated amounts of asbestos. This material was observed throughout the basement of the building. Small sections were observed in poor/fair condition, as seen above.
