# Health Canada Laboratory

## 2301 Midland Avenue

PWGSC Project R.054345.001

## DESIGNATED SUBSTANCES AND HAZARDOUS MATERIALS SURVEY REPORT

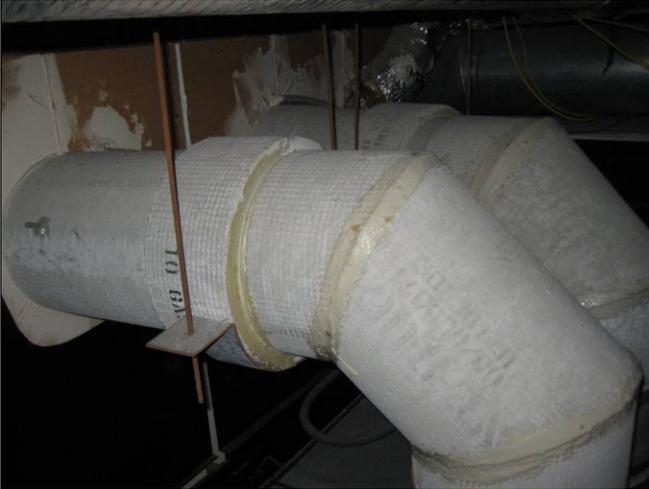
Asbestos Cement (Transite) Pipes were observed in the ceiling space above numerous fume hoods in the subject areas and in the service core area connecting Rooms 115 and 165. This material was visually confirmed to be asbestos-containing. The Transite pipes were observed to be in good condition.

**Photograph 1:** [Room 115] Asbestos-containing Transite cement pipe vents above fume hoods observed to be in good condition.

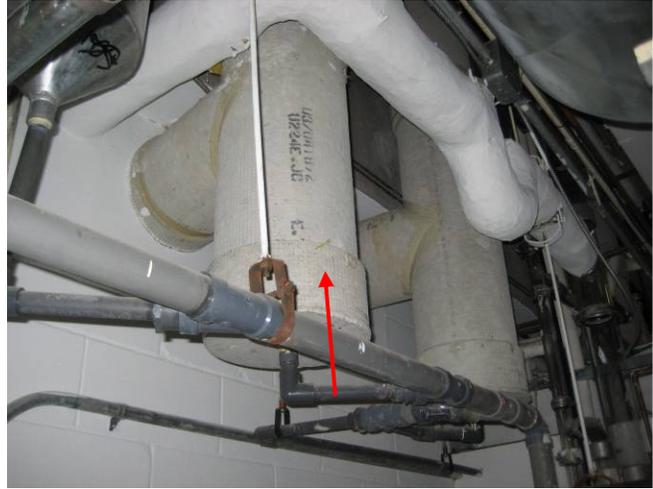
**Photograph 2:** [Service Cores] Asbestos-containing Transite cement piping observed to be in good condition.

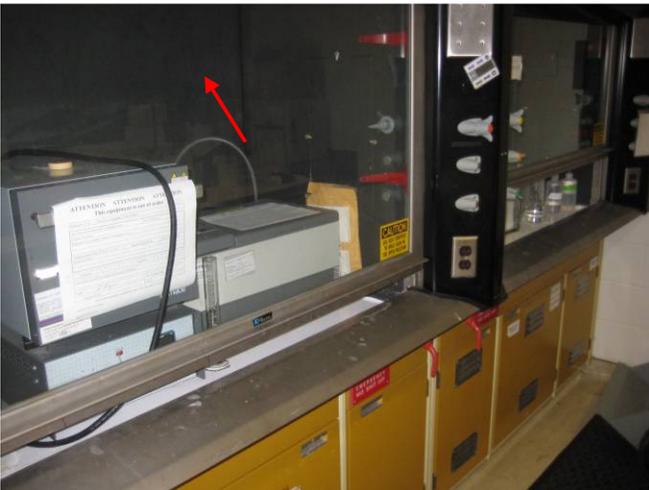
Fifteen (15) fume hoods with interior liners suspected of being asbestos-containing cement (Transite) were observed in the laboratories. Historically, these types of panels are known to be asbestos-containing. A representative from the fume hood manufacturer (Kewaunee Scientific Corporation) was contacted, and it was confirmed by the manufacturer that asbestos-containing panels were used in the manufacture of these early Kewaunee fume hood models. See **Appendix D** – Supplemental Information for information gathered from the fumehood manufacturer.

**Photograph 3:** [Room 225] Asbestos-containing Transite cement panels within fume hoods observed to be in good condition.

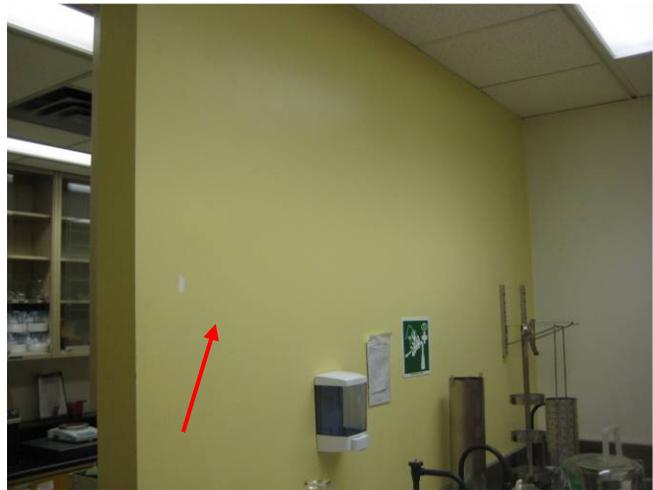
Gypsum board with drywall joint compound finishing application was observed mainly on the walls of Rooms 115, 165 and 225 (a small section of drywall ceiling was also observed). Samples of drywall joint compound were collected by Advanced Environmental Corp. (AEC) in a past survey of the subject building, from various ceilings and walls within the subject building (Sample Set V05) and analyzed for asbestos content. The drywall joint compound sampled by AEC was identified to contain up to 1% *Chrysotile* asbestos. Based on AEC's report the drywall within the subject areas was confirmed to be asbestos-containing, thus not sampled during this survey. The drywall was observed to be in good condition.

**Photograph 4:** [Room 165] Asbestos-containing drywall joint compound observed to be in good condition.

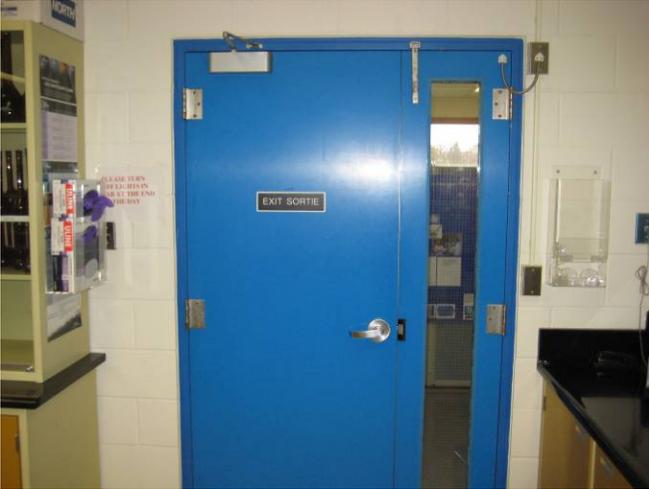
Location	Material Description	Assessment <sup>2</sup>	Action <sup>1</sup>
Room 225 Walls	White paint application (Approximately 325 m <sup>2</sup> )	- <b>Sample ID:</b> V-L-06 (AEC Report, 2009) <sup>2</sup> - <b>Concentration:</b> <0.0213 % - <b>Condition:</b> Good	<b>Routine Surveillance</b>  During removal this material is to be removed following asbestos abatement procedures based on the underlying material (see DJC in Table 3)
Room 225 Door Frames	Blue paint application (Approximately 32.5 m <sup>2</sup> )	- <b>Sample ID:</b> HC-L1 - <b>Concentration:</b> 0.26 % - <b>Condition:</b> Good	<b>Routine Surveillance</b>  Follow <b>Type 1</b> – if the coating is removed with a chemical gel or paste  or  Remove and dispose of entire door as lead-containing waste.
Room 165 Walls	Light Yellow paint application (Approximately 37 m <sup>2</sup> )	- <b>Sample ID:</b> HC-L2 - <b>Concentration:</b> Presumed <sup>3</sup> - <b>Condition:</b> Good	<b>Routine Surveillance</b>  During removal this material is to be removed following asbestos abatement procedures based on the underlying material (see DJC in Table 3)

**Photograph 5:** [Room 225] Lead-containing white wall paint application (V-L-06) and blue door frame paint (HC-L1), both observed to be in good condition.

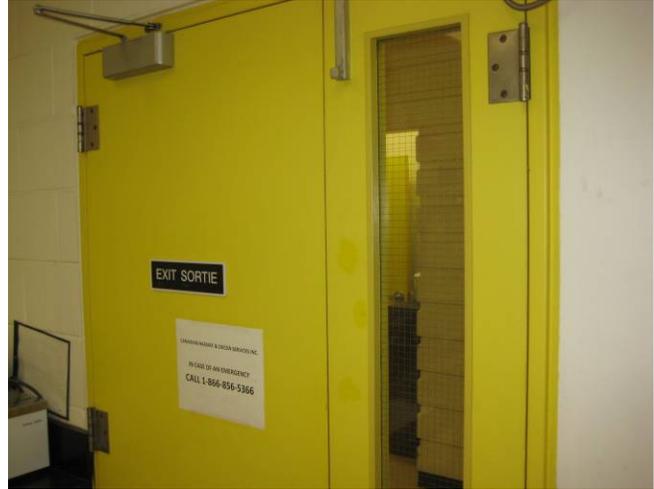
Location	Material Description	Assessment <sup>2</sup>	Action <sup>1</sup>
Room 165 Door Frames	Yellow paint application (Approximately 37 m <sup>2</sup> )	- <b>Sample ID:</b> HC-L3 - <b>Concentration:</b> 0.95 % - <b>Condition:</b> Good	<b>Routine Surveillance</b> Follow <b>Type 1</b> – if the coating is removed with a chemical gel or paste or Remove and dispose of entire door frames as lead-containing waste.
Service Cores Floors	Grey paint application (Approximately 37 m <sup>2</sup> )	- <b>Sample ID:</b> HC-L5 - <b>Concentration:</b> 0.062 % - <b>Condition:</b> Good	<b>Routine Surveillance</b> It is not anticipated that this material will require removal.

**Photograph 6:** [Room 165] Lead-containing yellow paint application (HC-L3) observed to be in good condition.

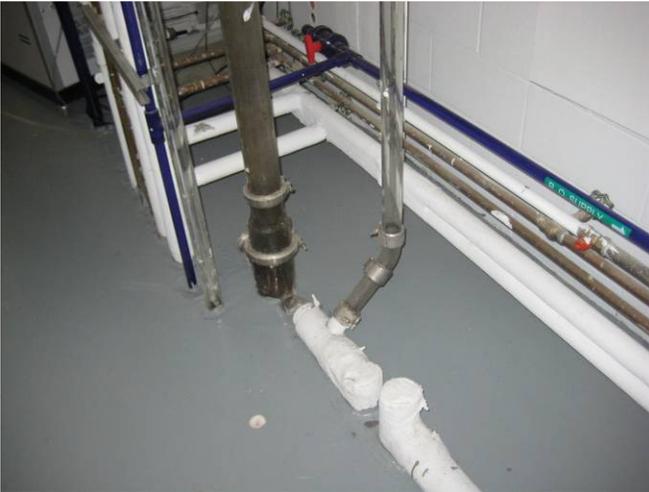
The lead concentrations of three (3) of the analyzed paints were found to exceed the threshold limit of 0.009% (lead by wt). Therefore, the blue door frame paint, yellow door frame paint, and grey floor paint applications are considered to be “lead-containing” under the federal *Hazardous Products Act (Surface Coating Materials Regulation)*. Additionally, white wall paint found throughout Room 225 was determined to be lead-containing by AEC during the past survey of the subject building. Lead-containing painted surfaces within the subject areas were observed to be in good condition, with minimal flaking, chipping or cracking.

**Photograph 7:** [Service Cores] Lead-containing grey floor paint application observed to be in good condition.
