Hazardous Building Materials Assessment

E0401—RCMP Detachment, 200 Highway 3,
Princeton BC

March 17, 2020

Project No.: 123221396
PSPC Project No. R. 105597.001

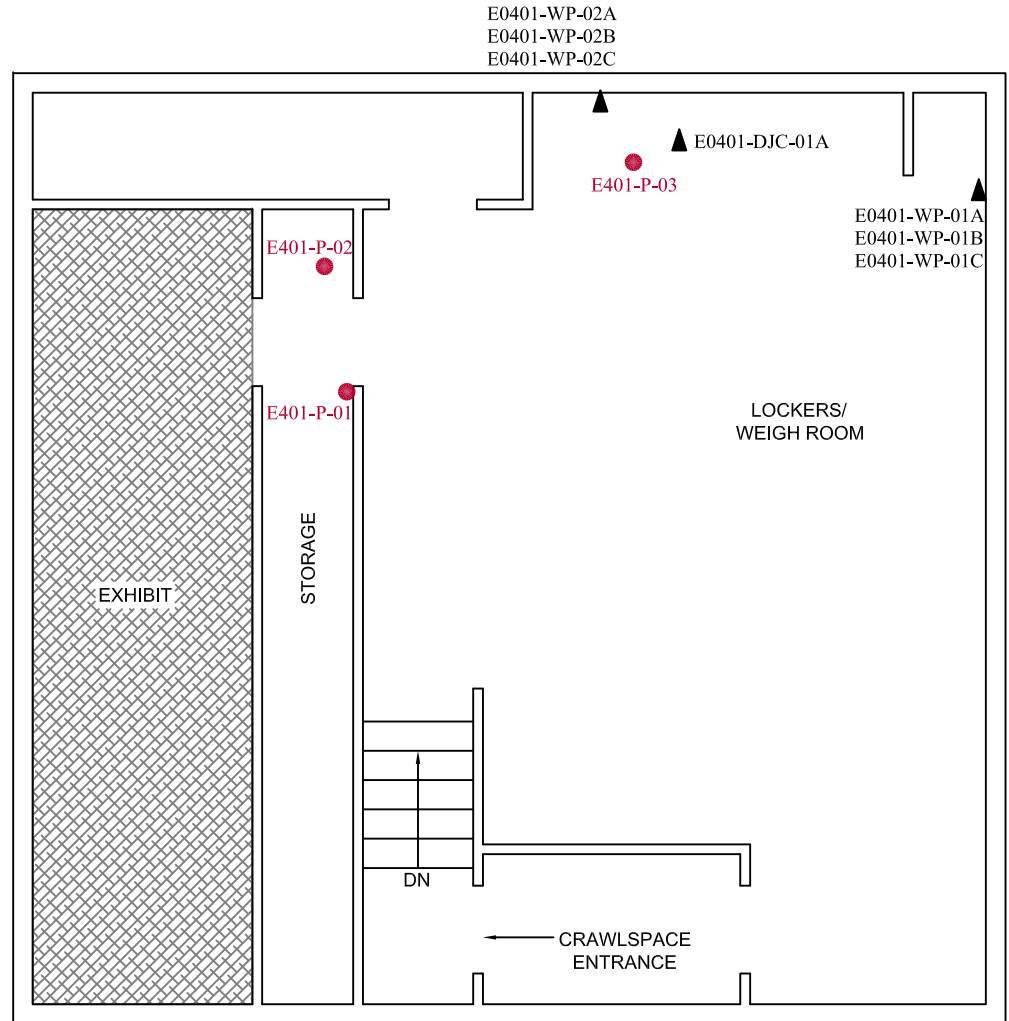
Dwg. No.:
3

- NOTES:** 1. WHITE DUCT TAPE ON SQUARE AND ROUND DUCTING POTENTIALLY CONCEALED THROUGHOUT IS ASBESTOS-CONTAINING.
 2. DRYWALL JOINT COMPOUND APPLIED TO WALLS AND CEILINGS THROUGHOUT IS ASBESTOS-CONTAINING.
 3. THIS DRAWING ILLUSTRATES SUPPORTING INFORMATION SPECIFIC TO A STANTEC CONSULTING LTD. REPORT AND MUST NOT BE USED FOR OTHER PURPOSES.

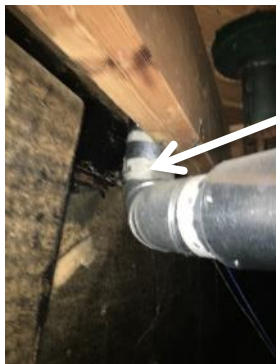
Identified ACM Description and Condition Information	
White duct tape on square and round ducting (only observed to be present in the crawlspace and potentially present in other concealed areas).	
% Type	64.1% Chrysotile (Current Assessment) 80% Chrysotile (Previous Report)
Friability	Friable
Condition	Good
Accessibility	Access (C) Concealed
Action	ACTION 7 (Routine Surveillance)
Approx. Quantity	5 linear metres

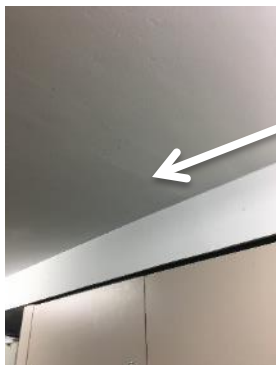
Drywall joint compound applied to drywall walls and ceilings throughout.	
% Type	1-2% Chrysotile (Current Assessment) 2-4% Chrysotile (Previous Report)
Friability	Non-friable in situ; potentially friable during removal
Condition	Good
Accessibility	Access (A)
Action	ACTION 7 (Routine Surveillance)
Approx. Quantity	220 square metres

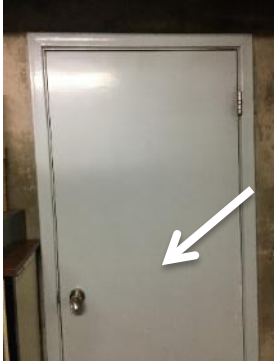
LCP Description		Photo
Paint colour	Light blue (grey in Previous Report)

Substrate	Wood	
Location/approx. extent	Doors and frames	
Lead content	3,600 ppm (Current Assessment) 1,800 ppm (Previous Report)	
Condition	Good	
Paint colour	Light yellow

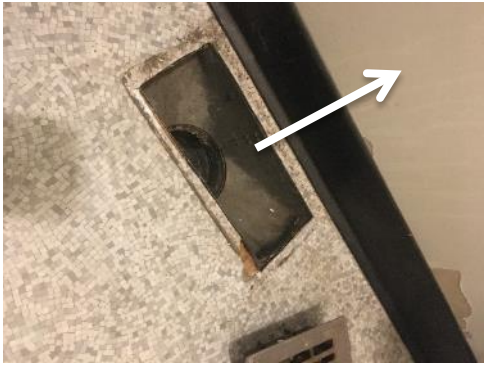
Substrate	Metal and concrete	
Location/approx. extent	Cell doors and walls	
Lead content	<750 ppm (insufficient sample to reach reporting limit, further sampling may determine that this is not in fact an LCP)	
Condition	Good
