DESIGNATED SUBSTANCES SURVEY LOWER BREWERS BRIDGE AND BRASS POINT BRIDGE, KINGSTON, ONTARIO

AUGUST 06, 2021

DESIGNATED SUBSTANCES SURVEY

PROJECT NO.: 19M-01599-00
DATE: AUGUST 06, 2021

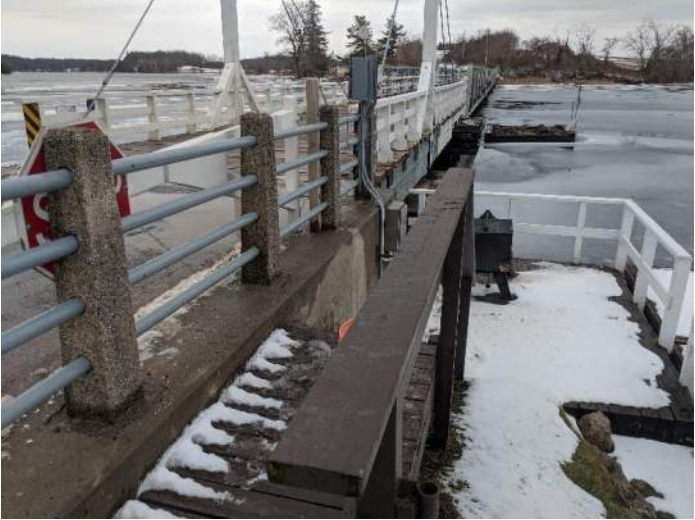
PHOTO NO.	MATERIAL DESCRIPTION & LOCATION	PHOTO
10	<p><u>Brass Point Structure</u> observed facing north east. Wooden stairs on the west side of the structure also observed.</p>

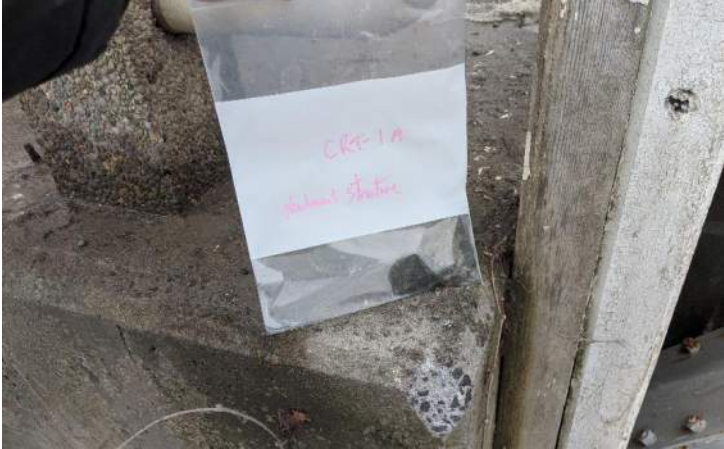
11	<p><u>Concrete sample CRT-1A, 1B, and 1C</u> observed and collected from the abutment structures.</p>

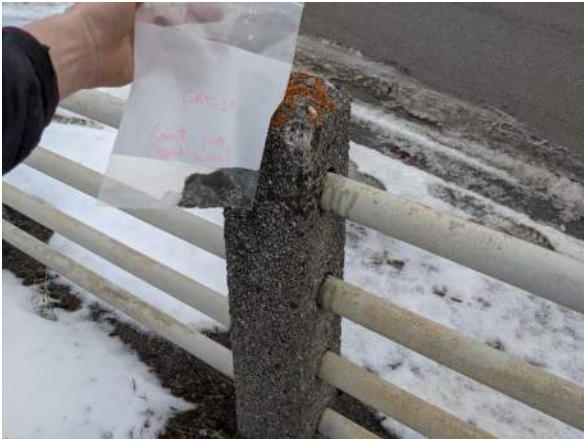
12	<p><u>Concrete sample CRT-2A, 2B, and 2C</u> observed and collected from the approach railing posts.</p>

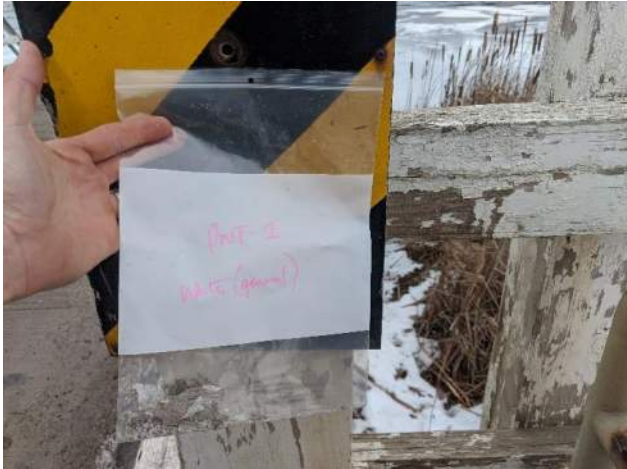
PHOTO NO.	MATERIAL DESCRIPTION & LOCATION	PHOTO
16	<p><u>Paint sample PNT-1</u> observed and collected from the safety rail on the north side of the deck.</p>

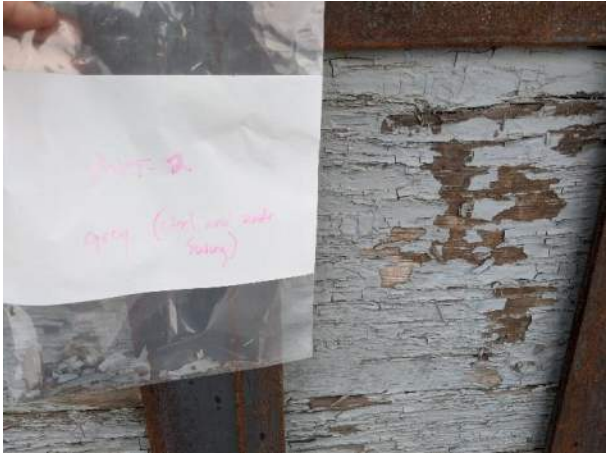
17	<p><u>Paint sample PNT-2</u> observed and collected from the south side of the deck, under the swing.</p>

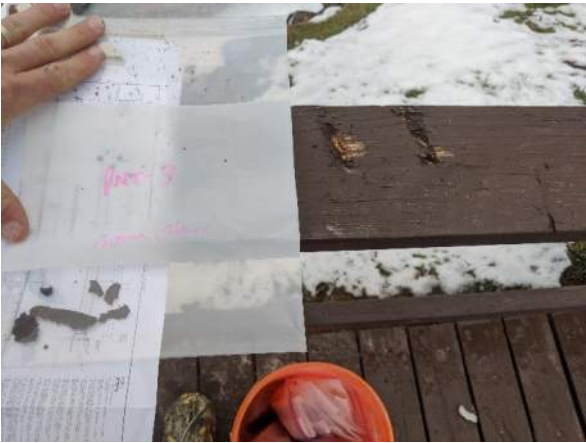
18	<p><u>Paint sample PNT-3</u> observed and collected from the wood stairs on the south west side of the structure.</p>
