POST CONSTRUCTION INSPECTION REPORT OF RADAR TOWERS

SITE: LANDRIENNE RADAR

ENVIRONMENT CANADA

MCA REFERENCE N°: 1642-100-1

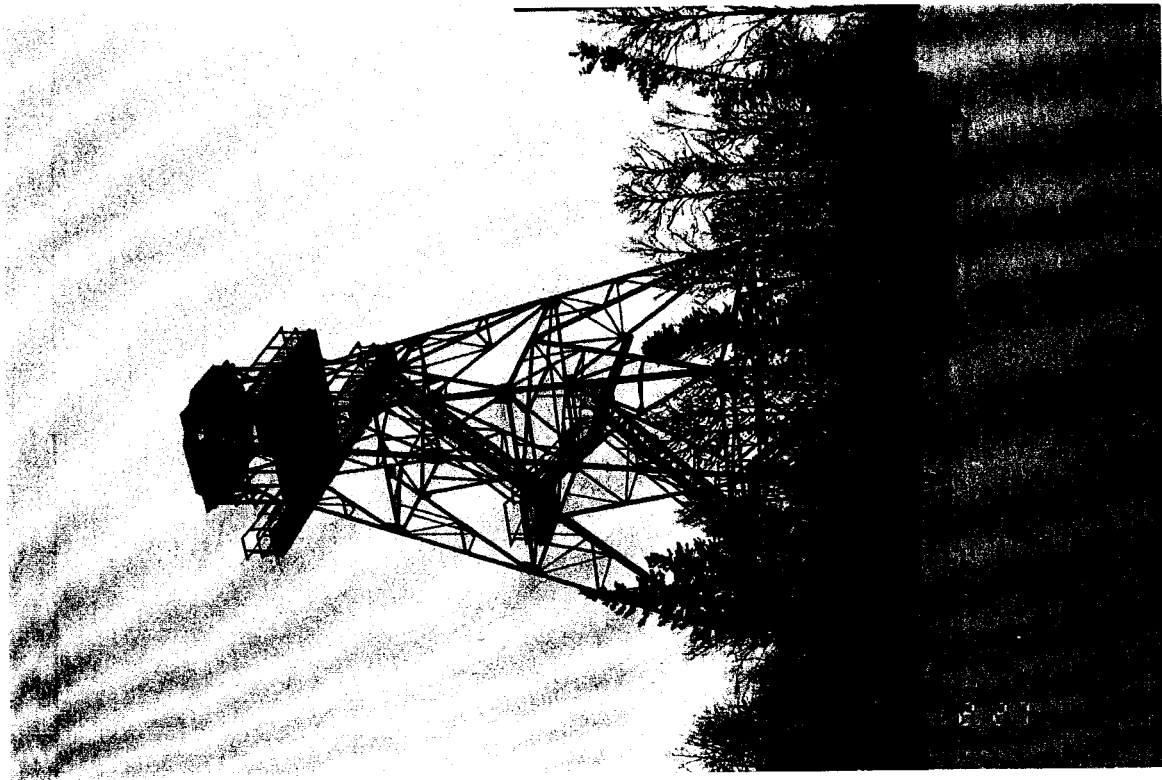
photo # 1

<u>Photo N°</u>	<u>Description</u>
1	Tower profile
2	Base of the tower leg
3	Foundation of the stairs
4	Diagonal gusset at the base of the tower
5	Missing diagonal under the top platform
6	Damaged secondary horizontal
7	New to recycled section connection
8	Bent interior bracing member
9	Opening at the platform level
10	Step in the grating platform
11	Stair stringer connection to platform at elevation 6m
12	Handrail post connection to platform at elevation 6m
13	Handrail at the top platform
14	Loose bolt
15	Loose bolt
16	Loose bolt
17	Missing bolt at the new interior bracing elevation
18	Missing spacer at elevation 6m
19	Missing spacer at elevation 6m
20	Missing bolts at elevation 6m
21	Handrail connection to leg at top platform elevation
22	Added member connection to channel
23	Rust under the radar platform
